Manhole Inspection Summary

Manhole # S33CC2019MH

Insp Date: **10/28/08 10:26 AM**

Location Address: **211 E NORTHERN PKWY**

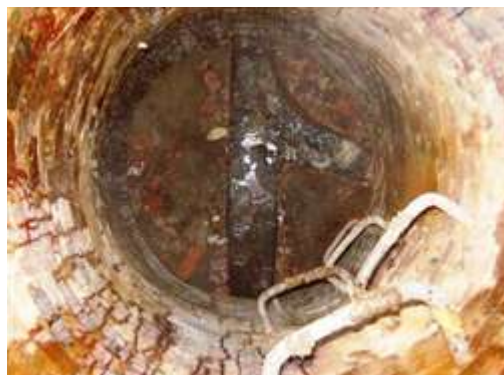
Top View

Evidence of surcharge - Bench debris.
Channel debris.

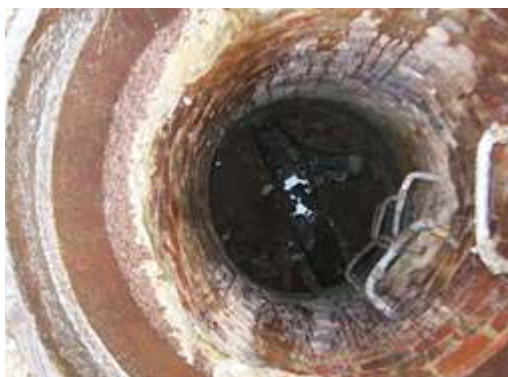
Defect

Frame leaks. Frame offset. Adjustment
and Barrel infiltration.

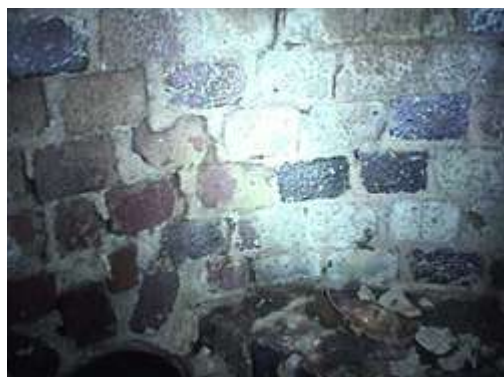
Defect

Barrel deterioration and infiltration.

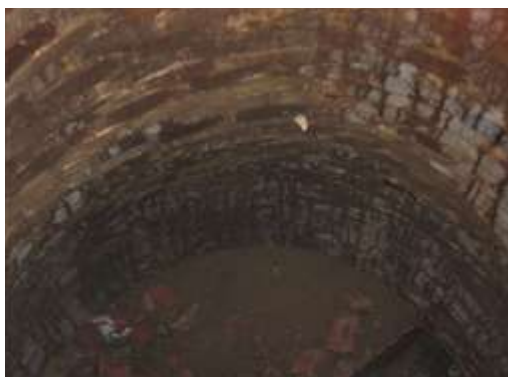
Defect

Barrel infiltration.

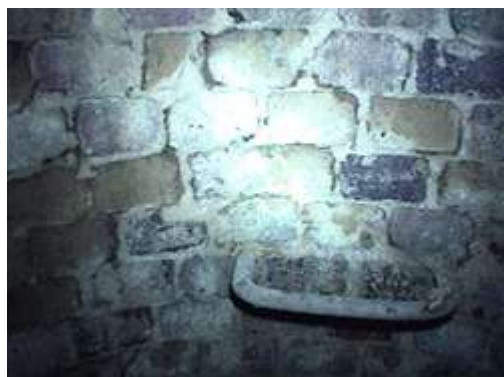
Defect

Barrel deterioration and infiltration.

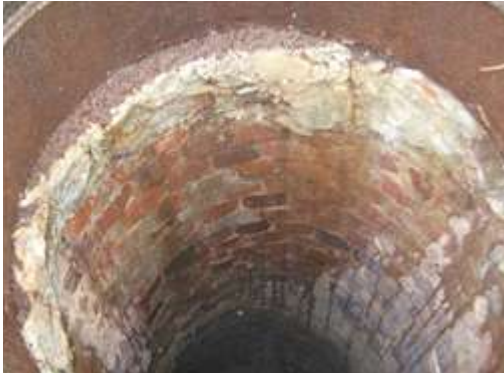
Defect

Frame leaks. Frame offset. Adjustment and Barrel infiltration.

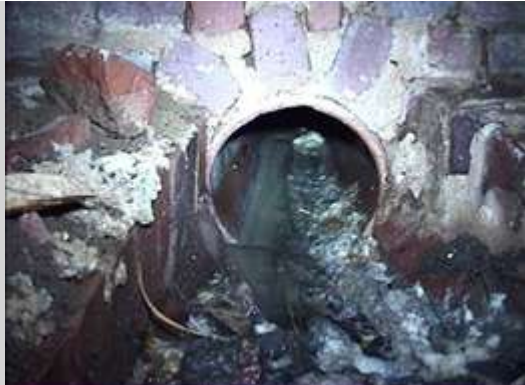
8 in. Circular Gravity Sewer Pipe Out @ 12 O'Clock

Deposits: ☐ None ☒ **Mud** ☐ Sludge ☒ **Debris** ☒ **Grease**

Silt Depth: **0** (in.) Deposits Extent: **Light**

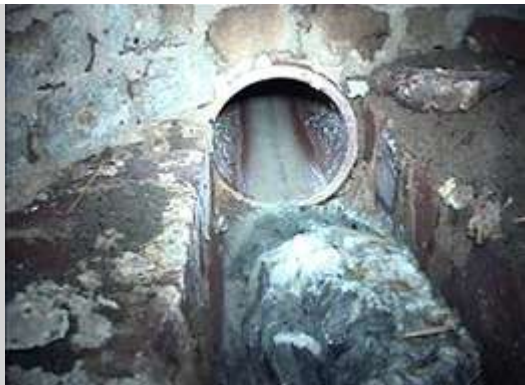
8 in. Circular Gravity Sewer Pipe In @ 3 O'Clock

Deposits: ☐ None ☐ **Mud** ☐ Sludge ☐ **Debris** ☒ **Grease**

Silt Depth: **0** (in.) Deposits Extent: **Light**

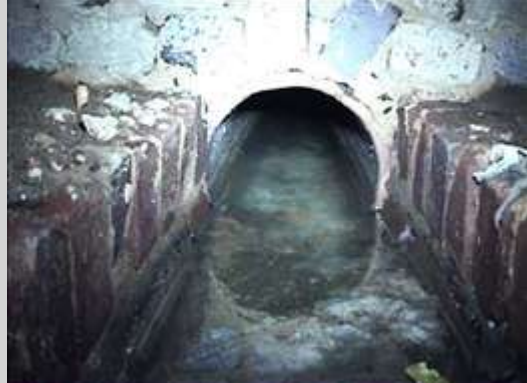
Pipe In @ 6 O'Clock

Deposits: ☐ None ☒ **Mud** ☐ Sludge ☒ **Debris** ☒ **Grease**

Silt Depth: **1** (in.)

Deposits Extent: **Light**
